Short Note

Rotational Earthquake Effects in the United Kingdom

by Susanne L. Sargeant and Roger M. W. Musson

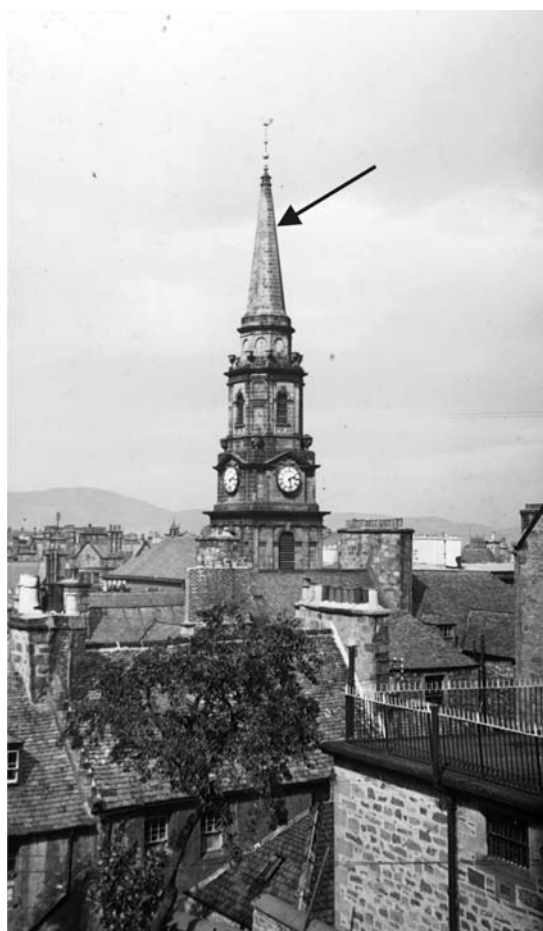
Figure 2. The spire of Inverness Jail. This picture was taken after the spire was restored. Arrow indicates approximately where the rotation occurred “within 5 or 6 feet of the top, the angles of the octagon turned nearly to the middle of the flat sides of the octagons underneath it” (Anonymous, 1816). This photograph is available as part of the Highland Photographic Archive (see Data and Resources section). Sense of rotation unknown.

probably southwest of the city (Musson, 1994) as shown in Figure 1b. One report notes that chimney tops were damaged throughout the city. Hugh Miller (Miller, 1905) wrote this account of the damage to the spire of the city jail (Fig. 2): “The neat, well proportioned, very uninteresting jail spire of the burgh, about which, in its integrity, no one cares anything, had been shaken by an earthquake ... by a strange vorticose motion, twisted round the spire, so that, at the transverse line of displacement, the panes and corners of the octagonal broach which its top formed overshot their proper positions fully seven inches. The corners were carried into nearly the middle of the panes, as if some gigantic hand, in attempting to twirl round the building by the spire, as one twirls round a spinning top by the stalk or bole, had, from some failure in the coherency of the masonry, succeeded in turning round only the part of which it had laid hold.”

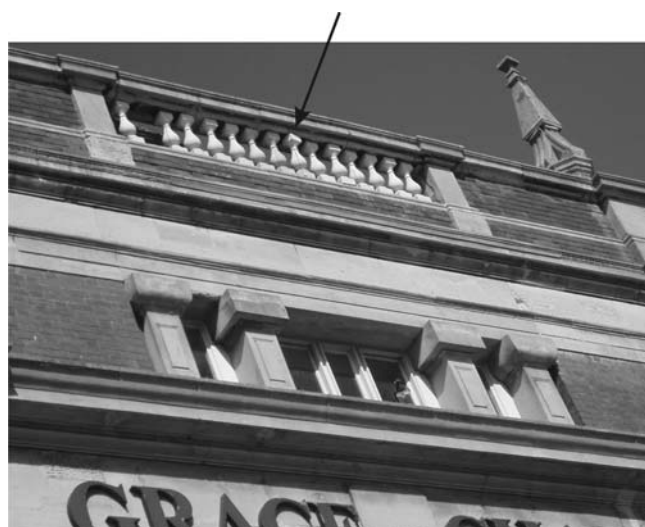
Figure 7. Balustrade support at Grace Chapel, Folkestone, rotated counterclockwise out of position (Sargeant, NERC, 2007).

This is the most recent example of rotational damage from a British earthquake although it is by no means unequivocal. The 2007 earthquake ($4.3 M_L$, Fig. 1d) caused significant, albeit localized damage in the Foord district of Folkestone, a few kilometers northwest of the epicenter. Most of the damage here was to chimneys although there were some instances of structural damage (Sargeant *et al.*, 2008). In this area at least one of the balustrade supports at the Grace Chapel appears to have been rotated out of position (Fig. 7).
